**GOVERNMENT OF INDIA
MINISTRY OF WATER RESOURCES
GROUNDWATER INFORMATION BOOKLET
Nicobar District, A&N ISLANDS**

**By
J.S.Sharma,
Superintending Hydrogeologist
&
Amlanjyoti Kar
Scientist-D
Central Ground Water Board
Eastern Region, Kolkata**

NICOBAR DISTRICT

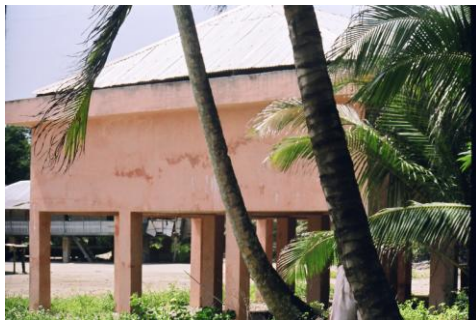
Fig- 5.2.5.1 One of the roof top rainwater Harvesting tanks in Chowra island

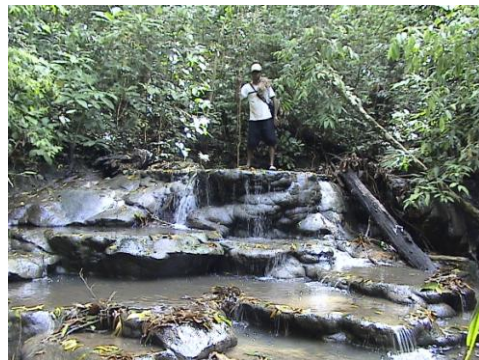
Fig-5.2.6.1 Mighty spring in Ophiolite in Ponda area, Teresa

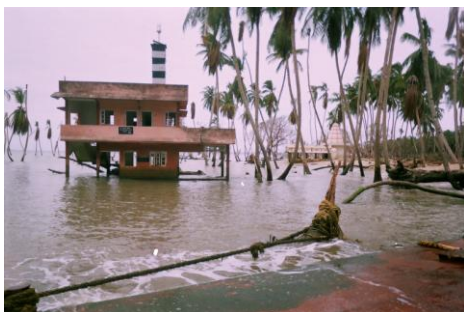
Fig- 5.3.2 Sea water ingress in Teressa

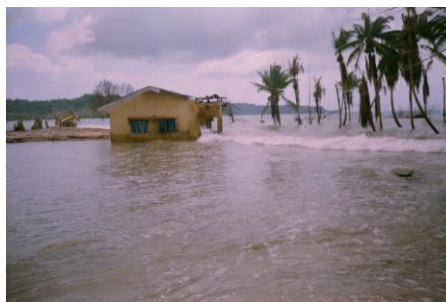
Fig- 5.3.3 Sea water ingress in Great Nicobar

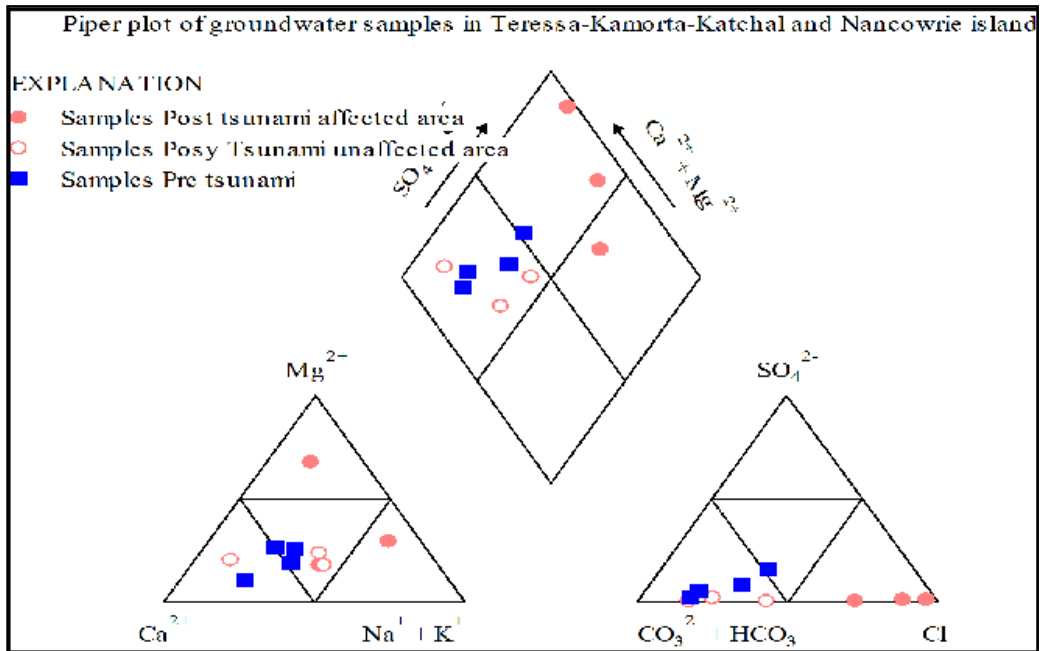
Fig-8.1,1 Piper plot of water samples in Pre & Post tsunami from Teresa-Kamorta-Katchal & Nancowrie Island

8.1 Qualitative changes in Pre and Post tsunami in Nicobar Group of Islands: Previously it has been repeatedly mentioned that the entire Nicobar Group of islands were severely devatated and subsided during the tsunami and Plate collision on 26.12.04. Considerable loss in rechargeable land resources has resulted in deterioration in the chemical quality as also deliene in the freshwater resources. The piper plot of chemical data(**Fig-8.1.1,8.1.2 & 8.1.3**) obtained from the islands have clearly focussed the change in quality of ground water data from Pre to Post tsunami.

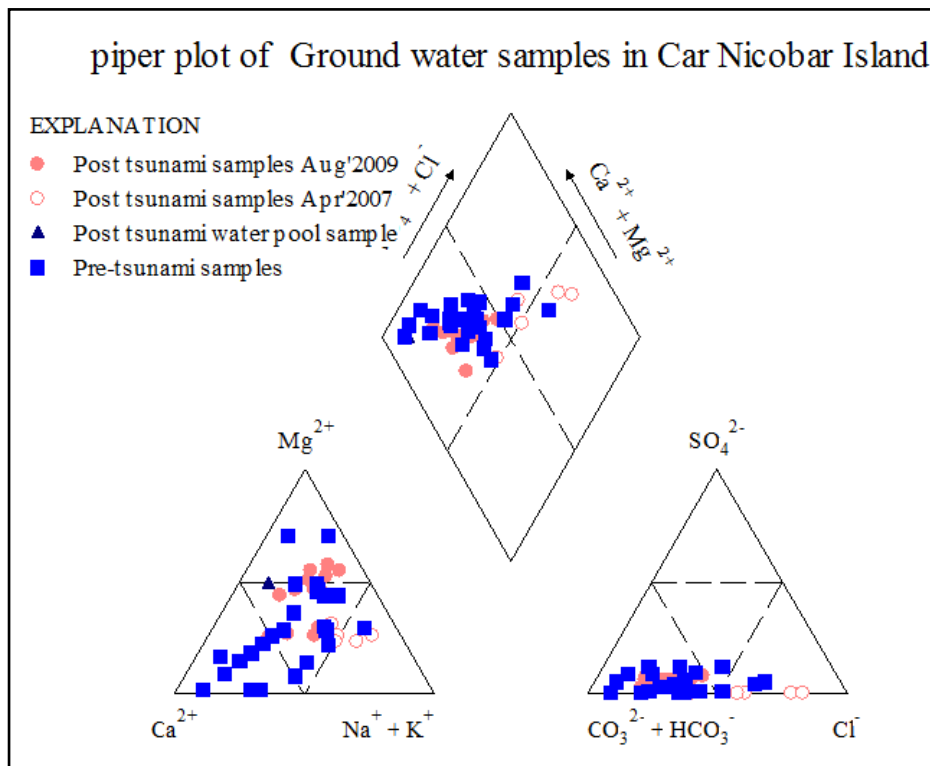
Fig-14.1.1 Piper plot of water samples in Pre & Post tsunami & Post Tsunami from Car Nicobar Is.

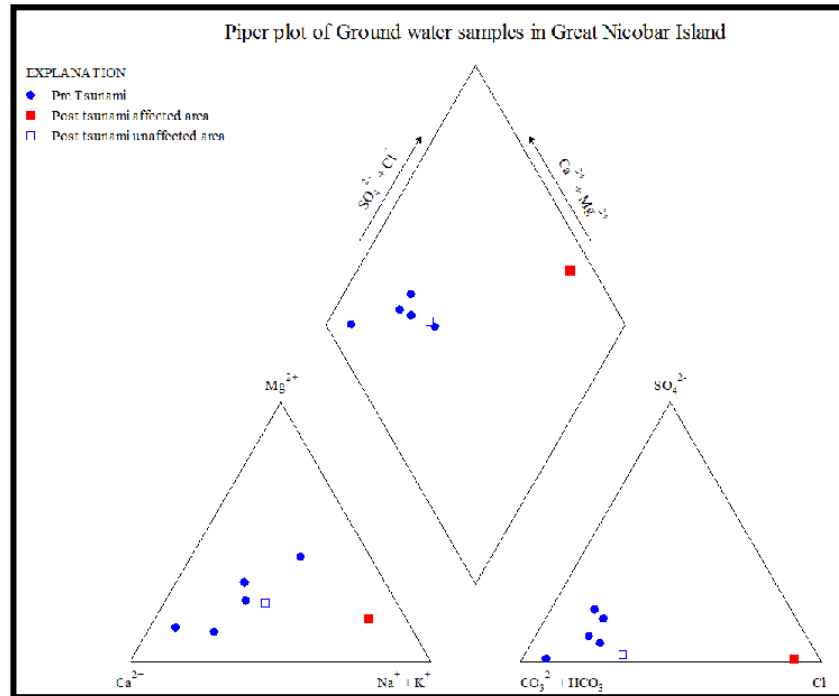
Fig-8.1.3 Piper plot of water samples in Pre& Post Tsunami from Great Nicobar Island

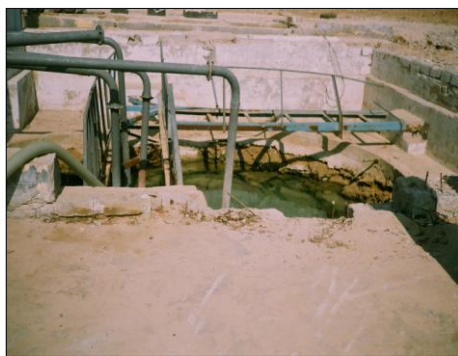
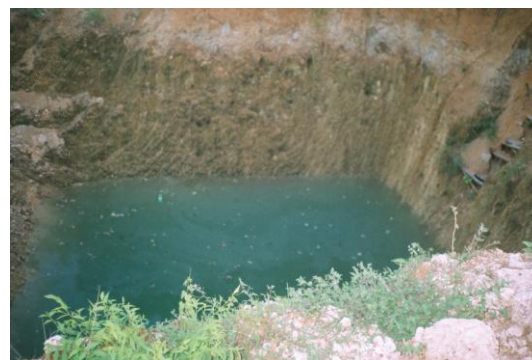
Fig- 10.1 a. Tsunami destroyed and contaminated well inside IAF campus, Carnicobar, b- New dug well under construction at Kakana, Car Nicobar, Water supply was delayed in view of qualitative sustainability
