AQUIFER MAPPING AND MANAGEMENT OF GROUND WATER RESOURCES

MANVI TALUK,
RAICHUR DISTRICT, KARNATAKA

AQUIFER MANAGEMENT PLAN OF MANVI TALUK, RAICHUR DISTRICT, KARNATAKA STATE

MARCH 2020

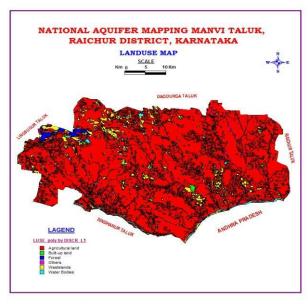
Fig. 2: Land use Map

It is observed that net sown area accounts for about 62% of total geographical area, while area sown more than once is 4% of total geographical area in the taluk. 52493 hectares is the gross irrigated area in the taluk. 90% of the gross irrigated area is irrigated through canals from Tungabhadra dam and the balance 10% gross irrigated area is catered through bore wells (**Table 5.**) and **Fig.2**.

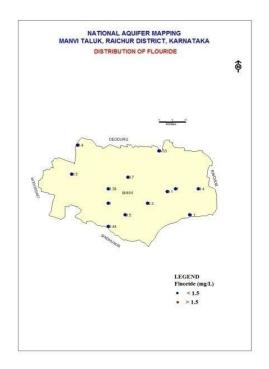
Fig.12: Distribution of Fluoride

In general, ground water quality in Manvi taluk is good for drinking purpose as per "Indian Standard Drinking Water Specification 2009". However, some parts in the north and north east of the taluk are affected by chloride contamination in groundwater which is > 3000 mg/l. Many parts of the taluk are affected by nitrate contamination of groundwater which is due to application of fertilizers to crops during cultivation. Distribution of Fluoride, EC and Nitrate are shown in **Fig. 12,13 & 14.**
